*Worldwide repairs carried out with PolymerMetal®*

**REP-# 067**

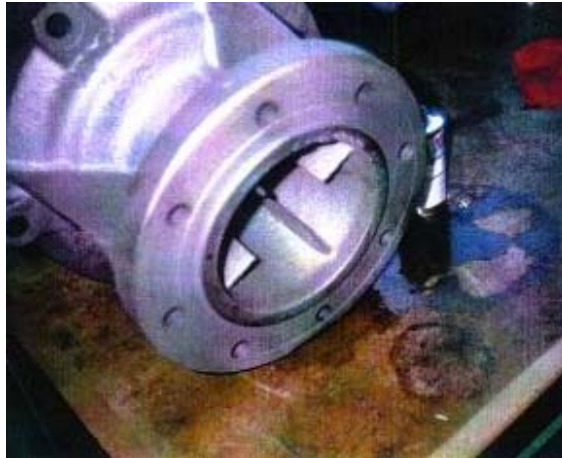
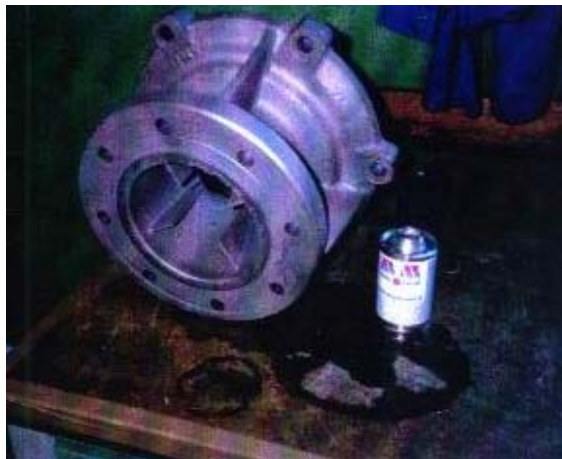
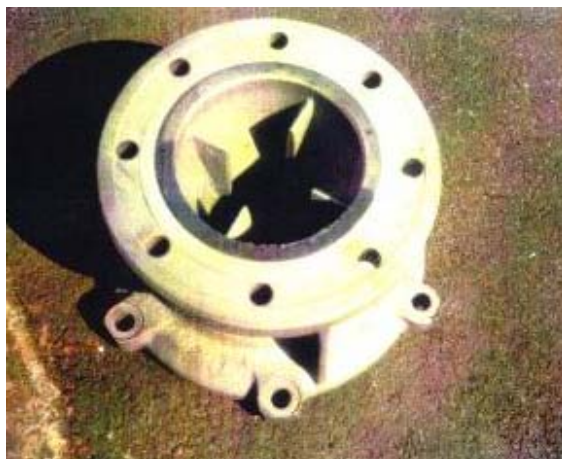
Cavitation damages on a flange were repaired by using Ceranium pasty and Hardener CE.
