Worldwide repairs carried out with PolymerMetal®

REP-# 084

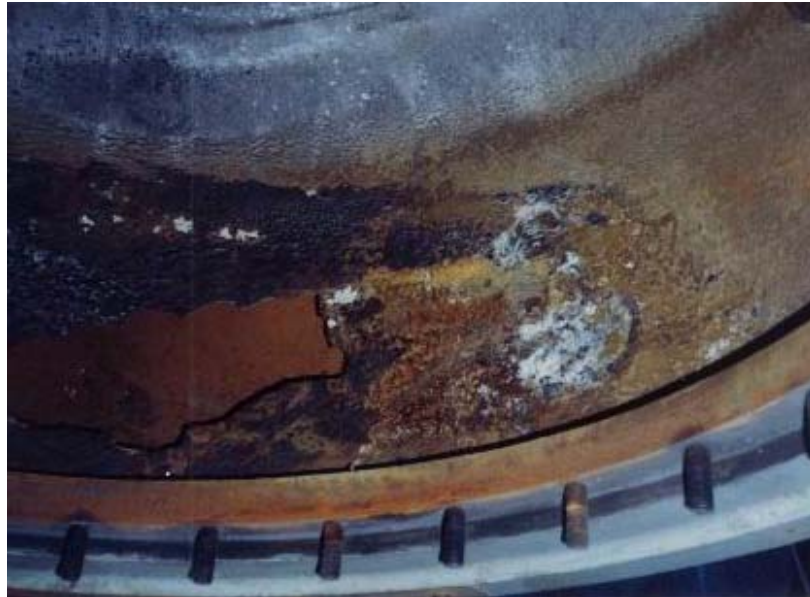
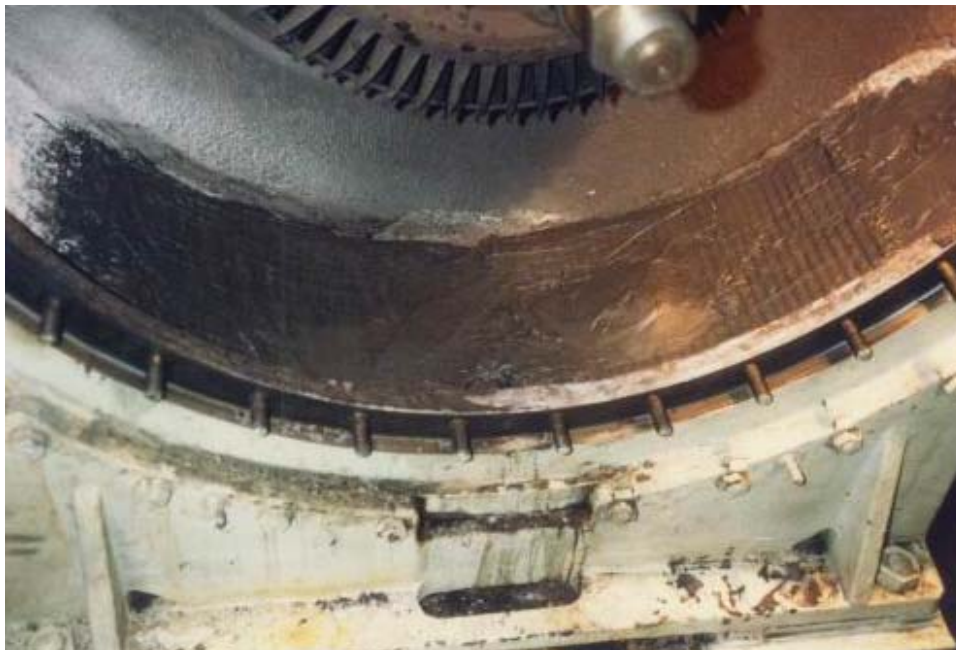
Repair of a turbo charger on board of a ship: during a voyage problems occurred at a turbo charger. The turbine inlet casing was removed and after cleaning a wasted area of appr. 600 mm x 130 mm on the lower part of the casing was revealed. Due to the technical possibilities on board the repair was carried out with MM-metal SS-steelceramic and a steel plate as reinforcement. At an exhaust temperature of appr. 400 °C in this repair area today MultiMetall's VP 10-500 would have been the better choice.
