## Worldwide repairs carried out with PolymerMetal®

REP-# 101

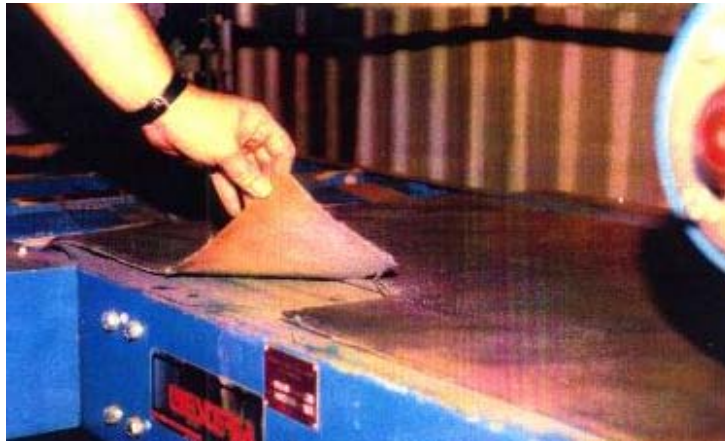
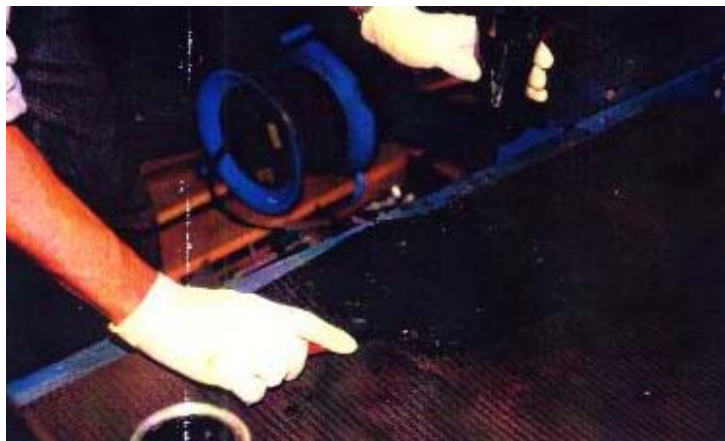
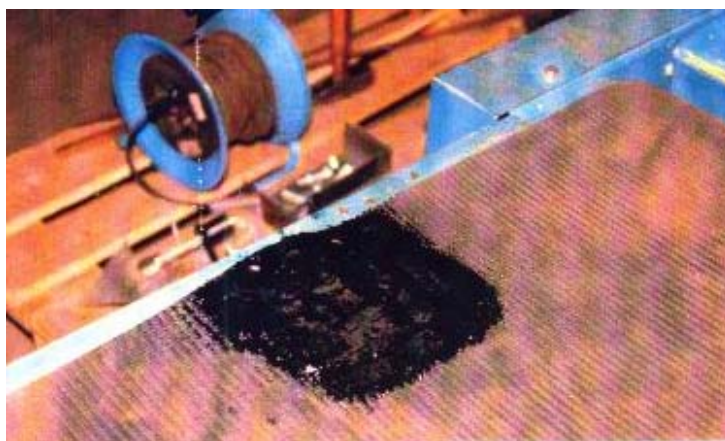
A conveying belt of a compost filling plant showed a 120 mm x 130 mm long triangle fracture at the corner. After cleaning and degreasing with MM-Degreaser Z an application of MM-Elastomer 95 with Hardener EL95 was done. Afterwards the conveying belt was put into action again with a tensile stress of 5 bar.
