Worldwide repairs carried out with PolymerMetal[®]

REP-# 023

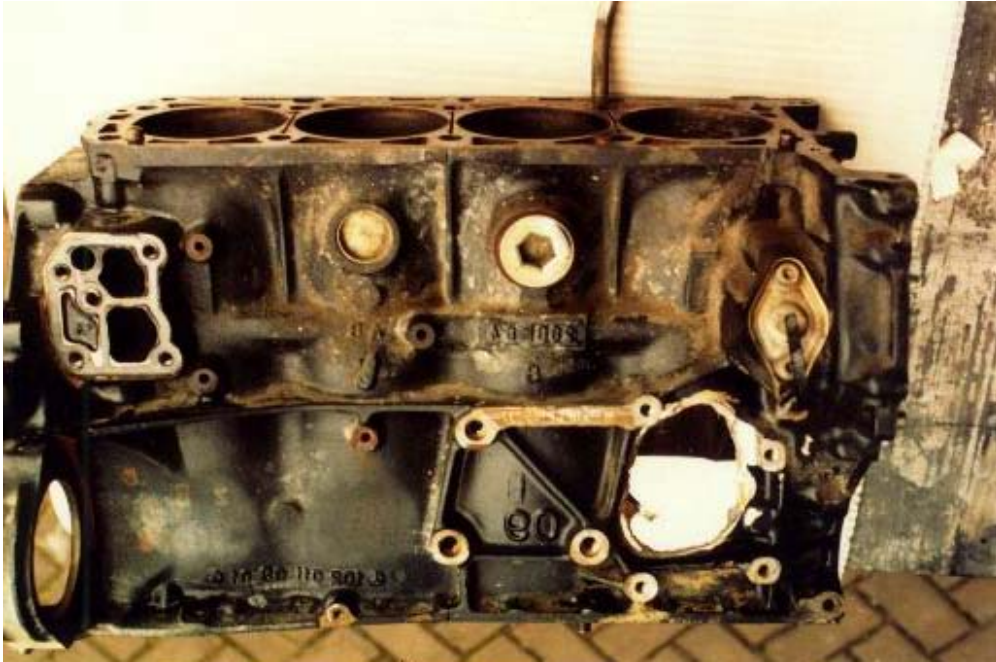
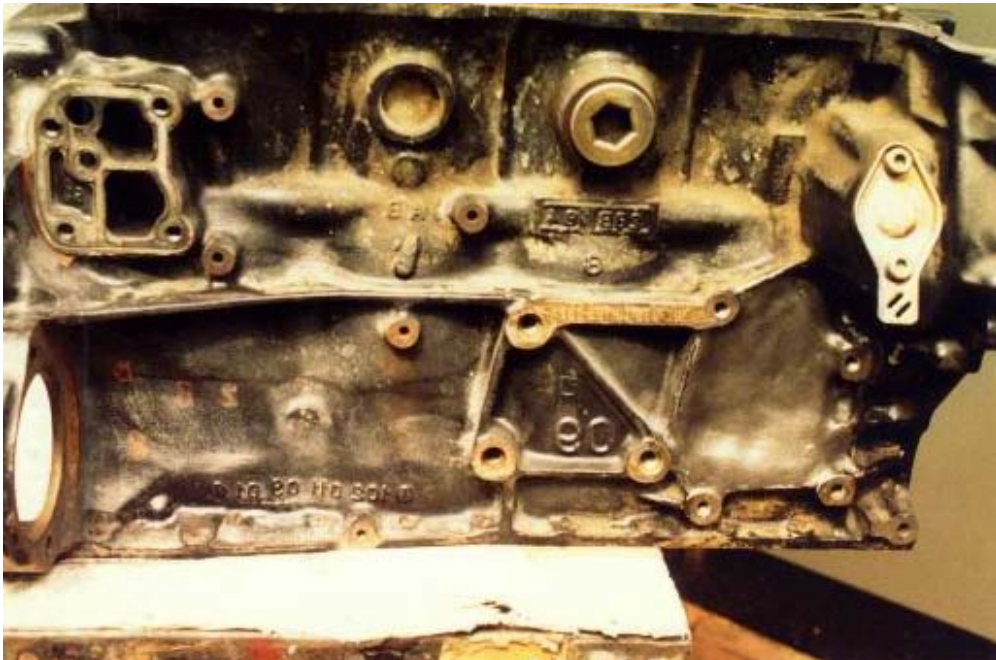
Repairing of a car engine Mercedes Benz near the crankshaft by using MM-metal SS-steelceramic and Hardener yellow. For reinforcement a 1 mm steel plate with the outline of the hole was patched into the engine.
