*Worldwide repairs carried out with PolymerMetal<sup>®</sup>*

REP-# 033

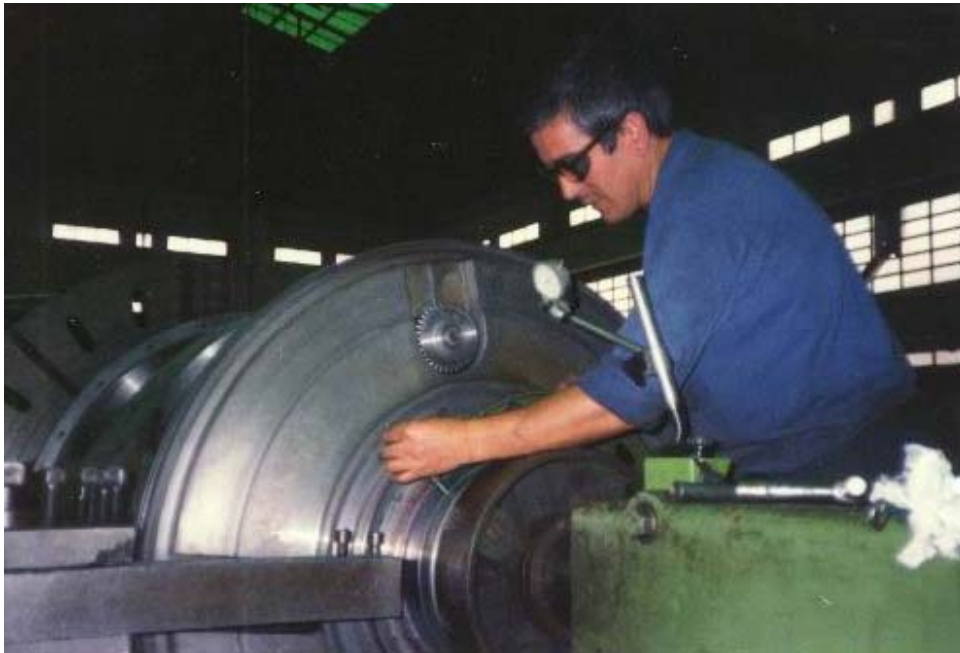
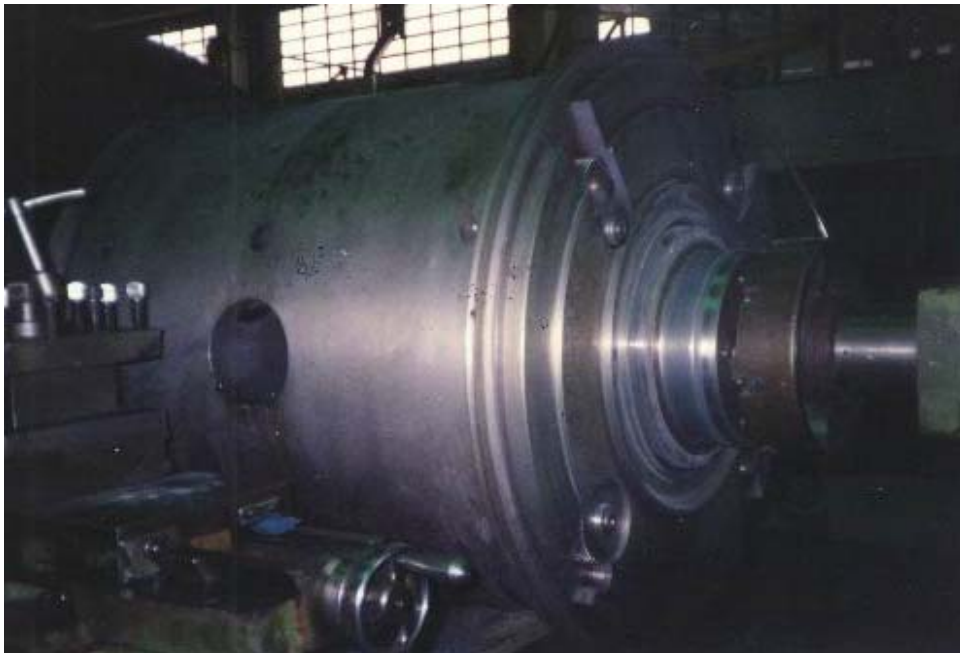
The seat of a ball bearing of a shaft, which serves for lining up, showed an abrasion of 0,2 mm. First the seat of the ball was turned off by 0,5 mm, then the repair site was cleaned with MM-Degreaser Z. Afterwards MM-metal SS-steel with Hardener yellow was applied. Finally the original shaft diameter was reached again by machining. Now the shaft was operational again without any problems.
