*Worldwide repairs carried out with PolymerMetal®*

**REP-# 048**

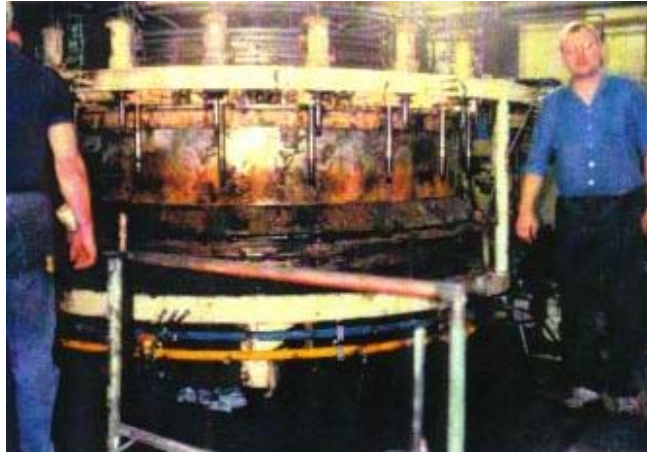
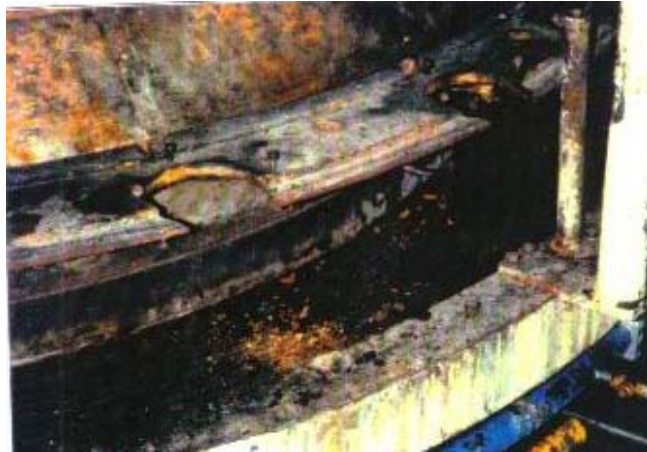
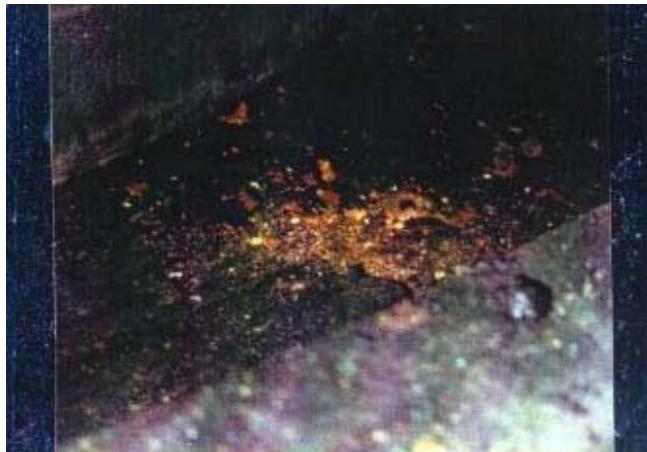
Repair of an automatic glass machine at a channel for broken glass and water. The coating procedure was affected in two steps - first application with Ceramium, pasty, followed by a second application with Ceramium, liquid. The previous reconstruction procedure was build-up welding.
