Worldwide repairs carried out with PolymerMetal®

REP-# 059

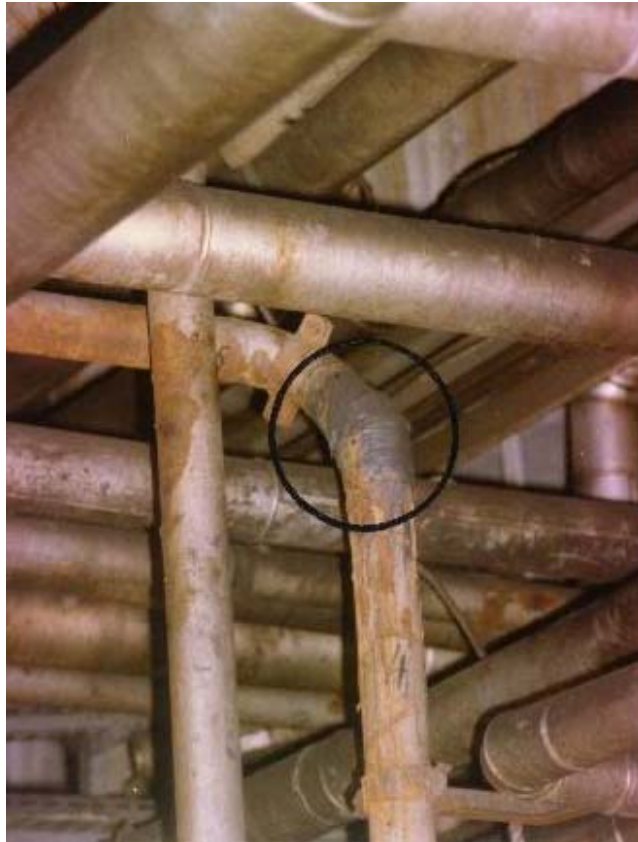
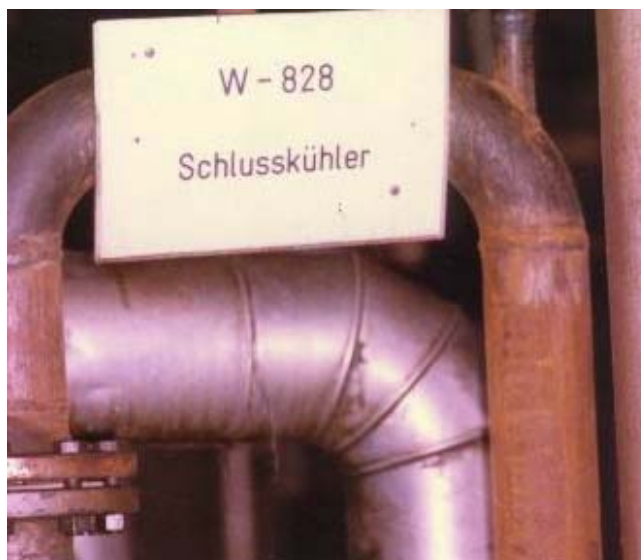
Sealing of a cooling water pipe in the high-hazard area of a high-pressure water installation without interrupting operation. The leakage was a 5 cm long crack at a water pressure of 2,5 bar. The sealing was carried out with MM-metal UW and Hardener UW3 without pressure reduction. Materials used were a pre-shaped metal sheeting and MM-Fabric tape (glass fibre).
